APPENDIX D

BIOLOGICAL RESOURCES DATA AND TECHNICAL REPORTS

**AGUA HEDIONDA AND CALAVERA CREEKS
JURISDICTIONAL DELINEATION REPORT FOR
WATERS OF THE U.S. AND STATE OF CALIFORNIA**

February 2007

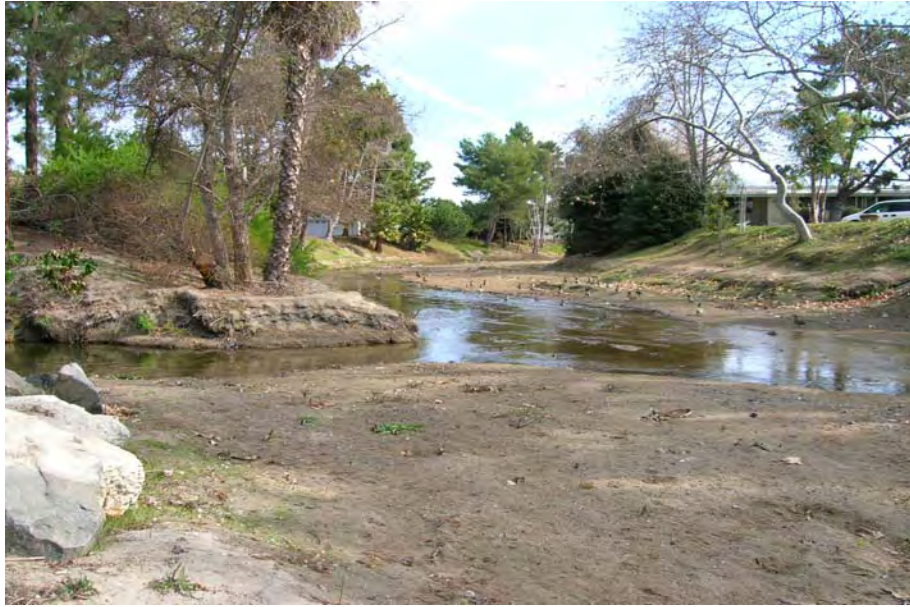
Figure 3. Agua Hedionda Creek at the confluence with Calavera Creek. Looking upgradient (east) from the El Camino Real Bridge

Agua Hedionda Creek between the El Camino Real and Cannon Road bridges consists of recovering riparian habitat composed of vegetation species such as willows (*Salix* sp.) and small patches of cattails (*Typha* sp.) (Figure 5). Agua Hedionda Creek in this area is also characterized by a wide channel and steep banks.

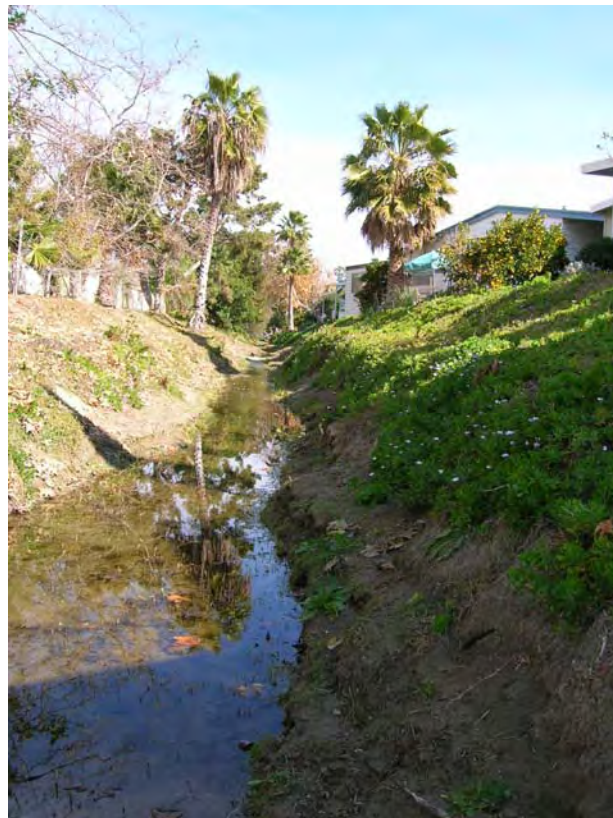
Figure 4. Calavera Creek

The results of the delineation for Calavera Creek identified the jurisdictional extent and boundary primarily related to hydric soil and hydrological parameters. No hydrophytic vegetation was observed within, at the toe, or on the banks (composed of graded slope) of Calavera Creek.

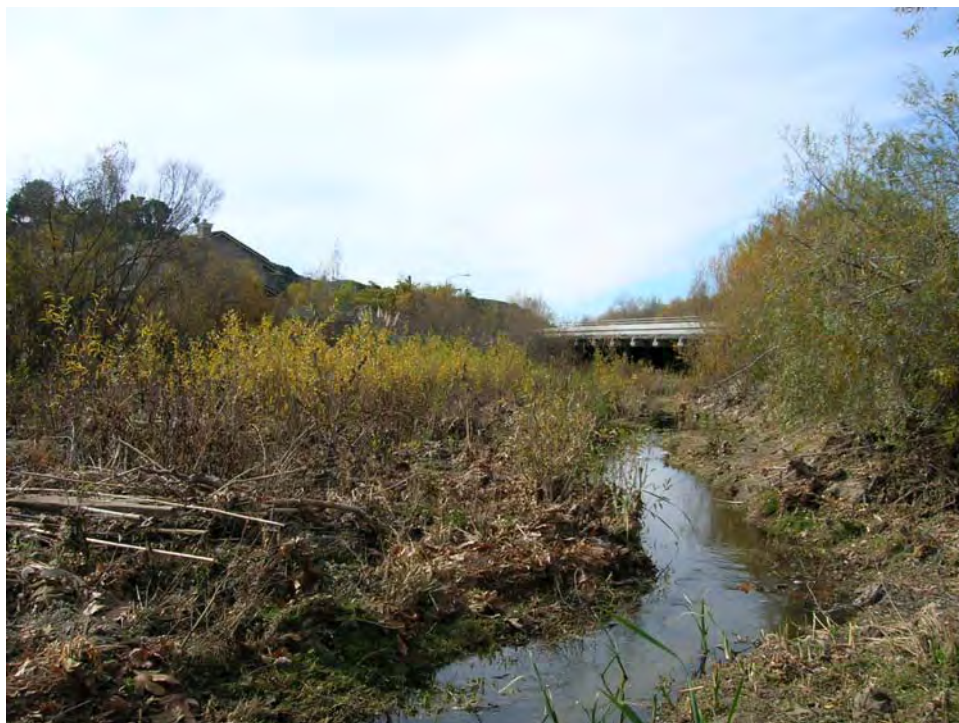
Figure 5. Agua Hedionda Creek at El Camino Real Bridge looking downstream (west) to the Cannon Road Bridge

Unvegetated channels are typically found within ephemeral drainages in southern California, where periodic high flows from seasonal storm events prevent the establishment of vegetation. Agua Hedionda Creek under the El Camino Real and Cannon Road bridges and east of the El Camino Real Bridge, and all of Calavera Creek consist of an unvegetated channel (Figures 3 and 4). Agua Hedionda Creek is characterized by a wide channel and steep banks. Calavera Creek is characterized by a very narrow channel and steep banks. Vegetation identified sparsely within the creeks includes nonnative herbaceous species such as water speedwell (*Veronica anagalis-aquatica*), dallies grass (*Paspalus dilatatum*), and green algae.

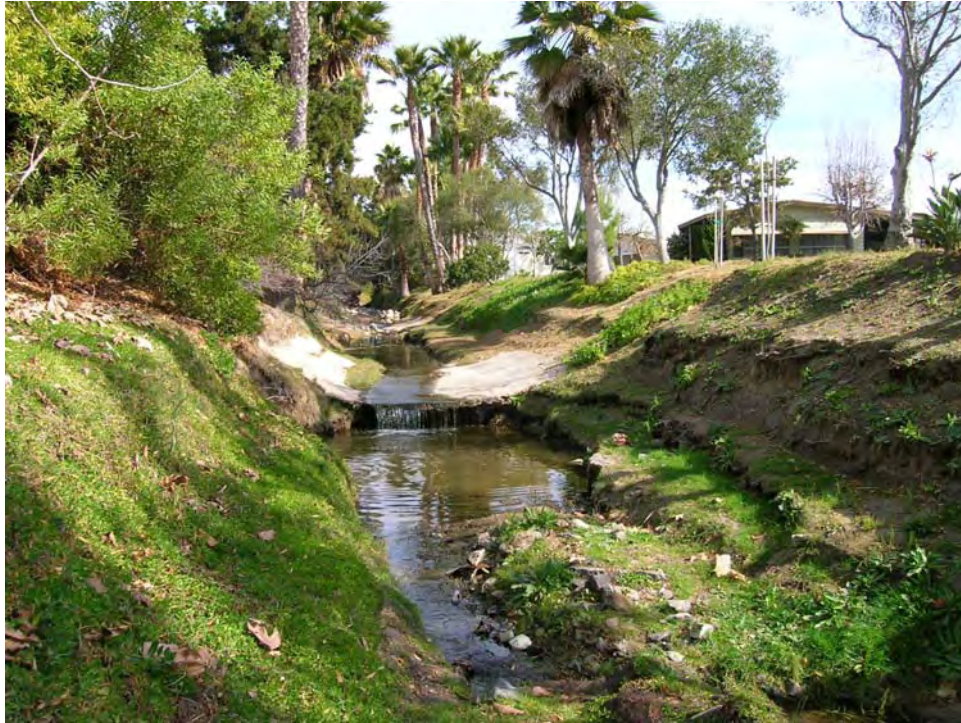
Figure 6. Calavera Creek

Riparian vegetation, which has been installed on the graded banks of Calavera Creek, is primarily composed of an installed ornamental overstory of bottlebrush (*Callistemon* sp.), eucalyptus (*Eucalyptus* sp.), pine (*Pinus* sp.), and an understory composed of exotic invasive herbaceous species such as African daisies (*Dimorphotheca aurantiaca*), ice plant (*Carpobrotus* sp.), and brome (*Bromus* sp.). Characteristic forbs include red-stem filaree (*Erodium cicutarium*), mustard (*Brassica* spp.), and tarweed (*Hemizonia* spp.). The nonnative/ornamental vegetation community consists of nonnative plant species typically used in residential or commercial landscape settings. Ornamental vegetation dominates the banks of the creeks within the Rancho Carlsbad residential community upstream of the El Camino Real Bridge. Much of the vegetation on the slopes of the Creeks is nonnative ornamentals, though several mature sycamores are interspersed along the banks of Agua Hedionda Creek. Though the vegetation within the creeks is routinely cleared, it is assumed that even in the absence of this activity, the vegetation would still be dominated by nonnative species. This is due to the large amounts of ornamentals planted on the banks and the adjacent upland areas that are developed or support nonnative vegetation, and concrete slabs from previous channelization (Figure 6).

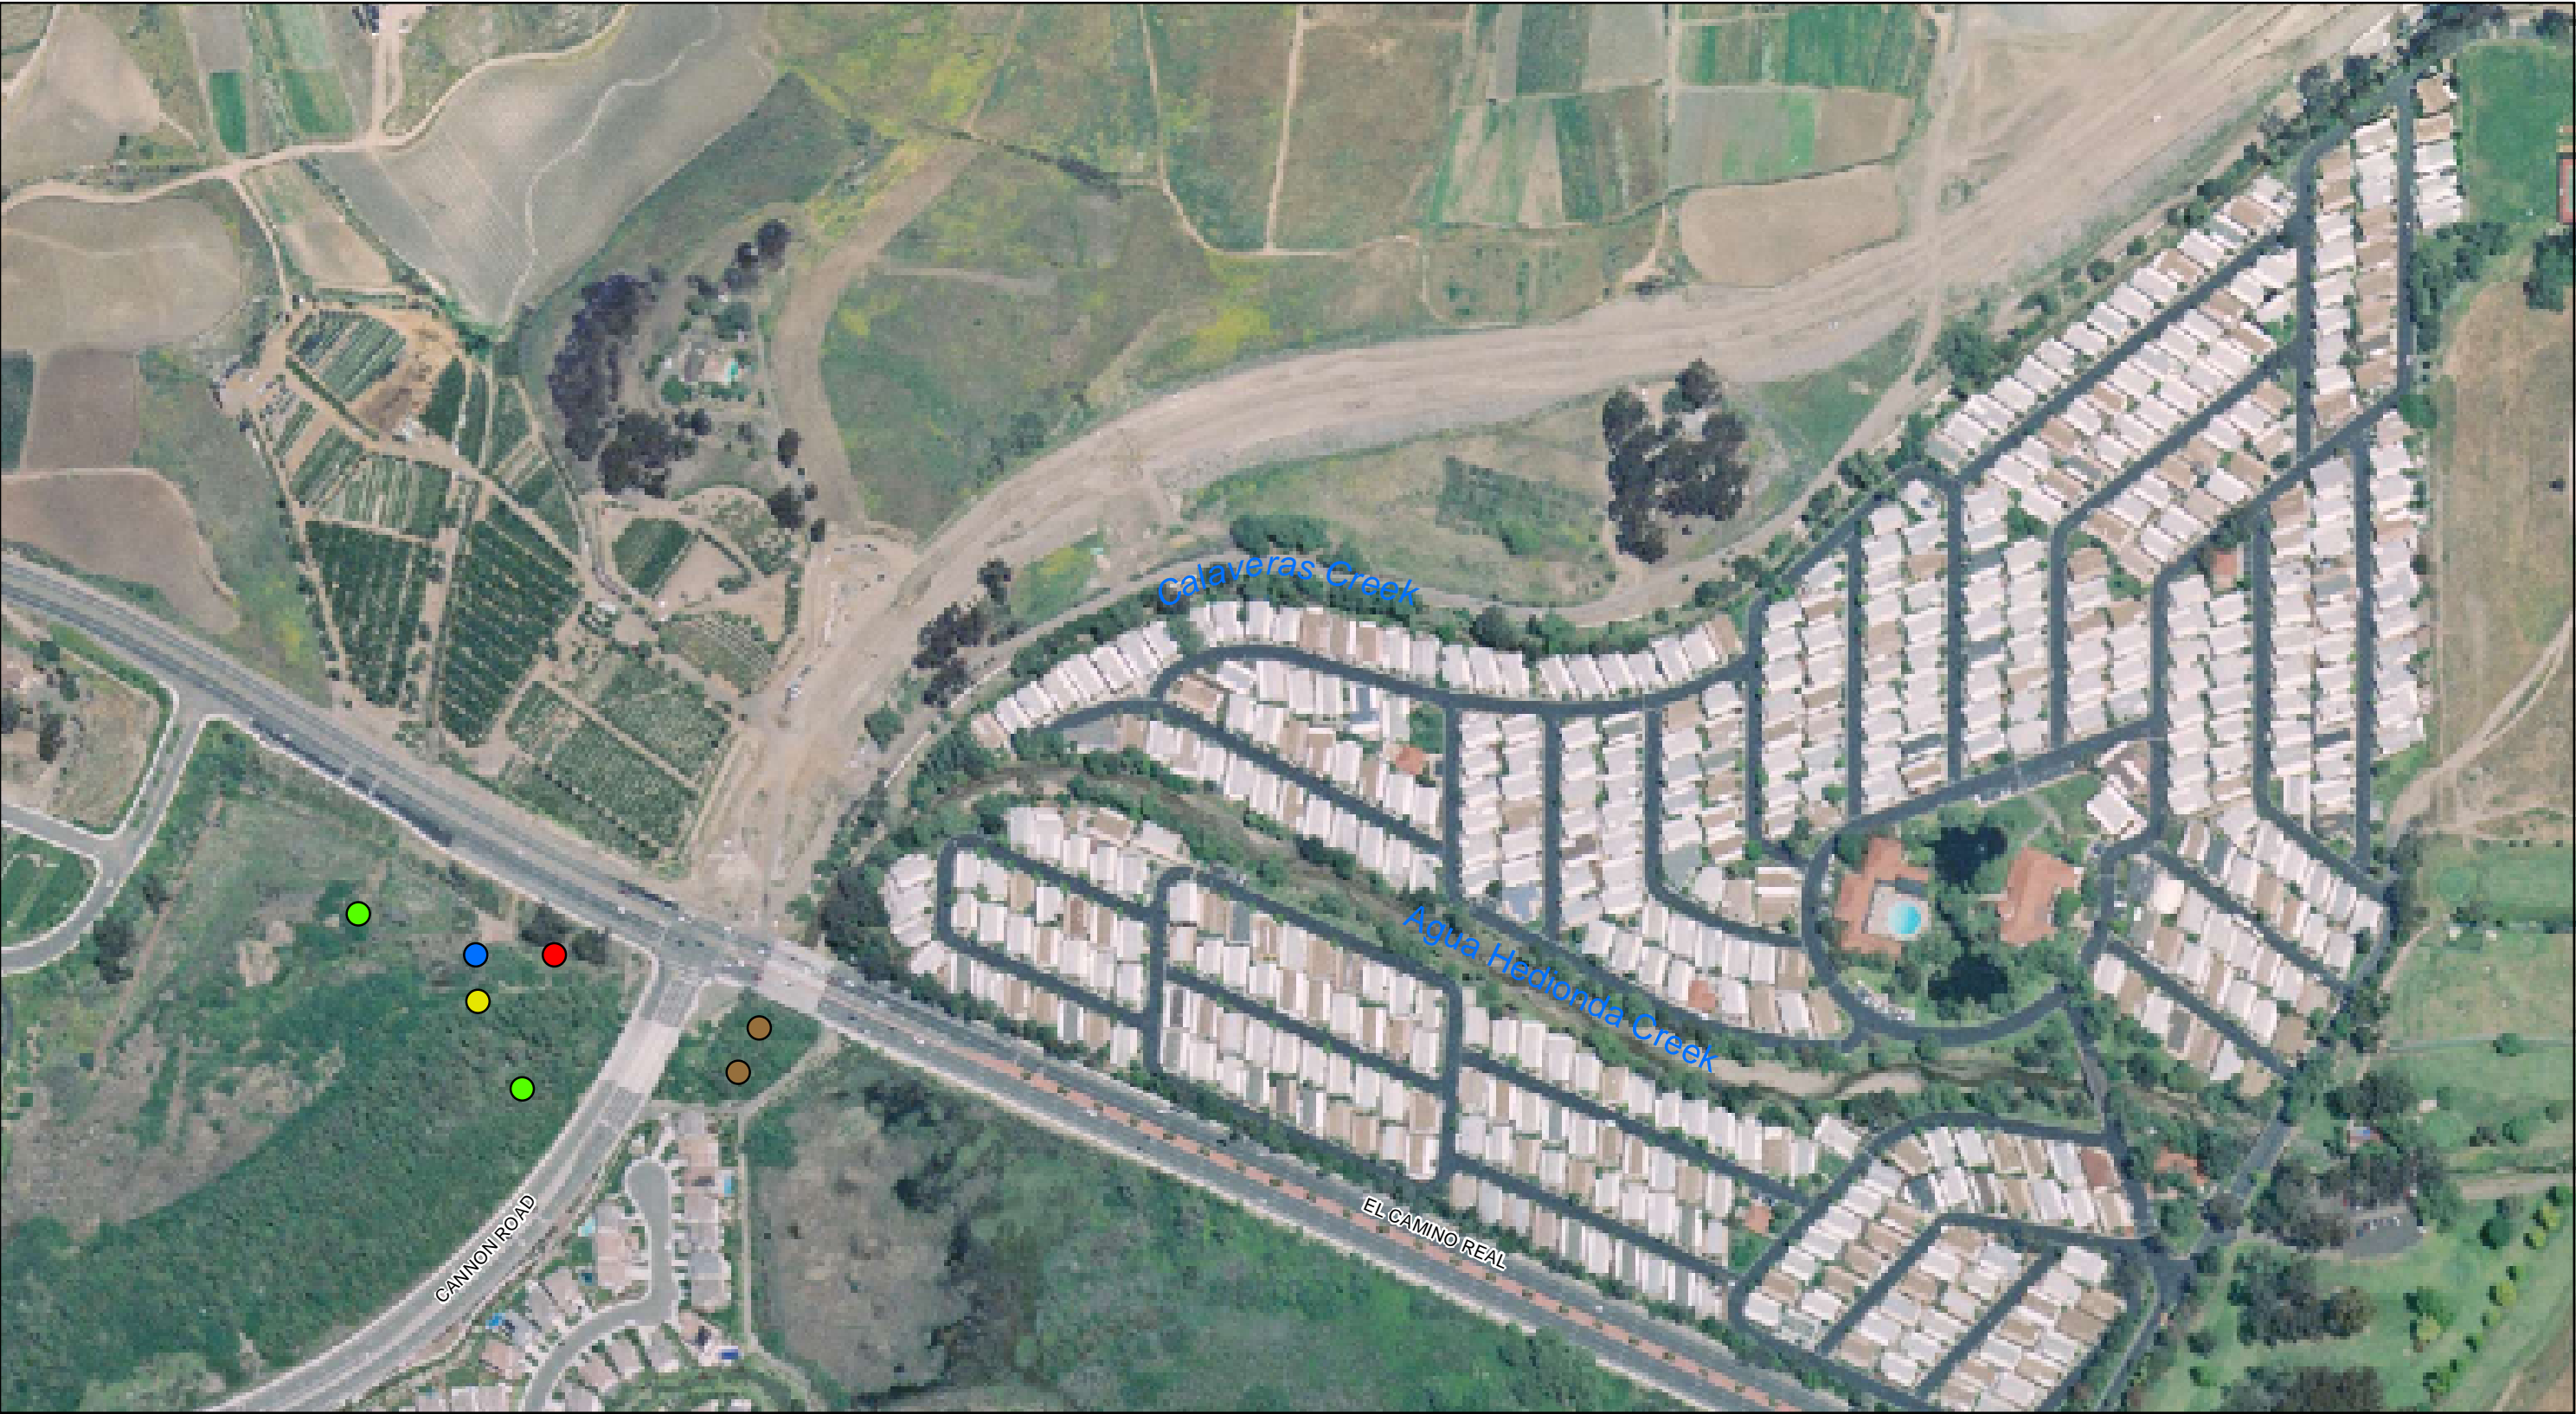
FIGURE 4
Sensitive Wildlife

- least Bell's vireo
- Southwestern willow flycatcher (05/19/05)
- Yellow-breasted chat
- Yellow warbler
- Brown-headed cowbird

One willow flycatcher and two least Bell's vireo were detected within the southern willow scrub along Agua Hedionda Creek west of the intersection of El Camino Real and Cannon Road. The willow flycatcher was detected during the first of the five focused surveys and was not seen during any of the subsequent surveys, indicating the individual was using the habitat as a stopping point during its migration north. One yellow warbler was detected within the southern willow scrub along Agua Hedionda Creek west of the intersection of El Camino Real and Cannon Road. One yellow-breasted chat was detected within the southern willow scrub along Agua Hedionda west of the intersection of El Camino Real and Cannon Road. The locations of these sensitive bird species are shown in Figure 4.

Birds commonly observed in the riparian areas during the surveys for least Bell's vireo and southwestern willow flycatcher included western scrub-jay (*Aphelocoma californica*), wrentit (*Chamaea fasciata henshawi*), lesser goldfinch (*Carduelis psaltria hesperophilus*), Pacific slope flycatcher (*Empidonax difficilis*), Anna's hummingbird (*Calypte anna*), bushtit (*Psaltirparus minimus*), orange-crowned warbler (*Vermivora celata*), common yellowthroat (*Geothlypis trichas*), spotted towhee (*Pipilo maculatus*), European starling (*Sturnus vulgaris*), and Nuttall's woodpecker (*Picoides nuttalli*). Two brown-headed cowbirds (*Molothrus ater*) were detected within the southern willow scrub along Agua Hedionda Creek south of Cannon Road and west of El Camino Real (see Figure 4).

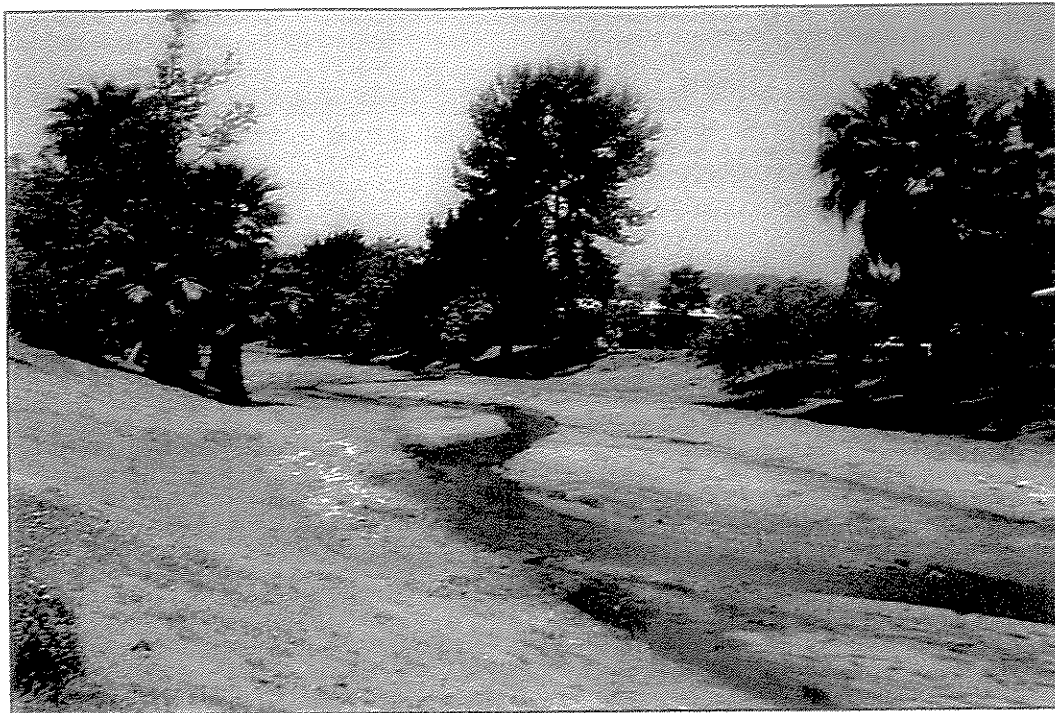
PHOTOGRAPH 1
Agua Hedionda Creek within RCMHP

The topography is relatively flat along Agua Hedionda Creek. Elevations on-site range from approximately 70 to 100 feet above mean sea level (AMSL). Representative photographs of this reach of Agua Hedionda Creek are provided (Photographs 1 and 2).

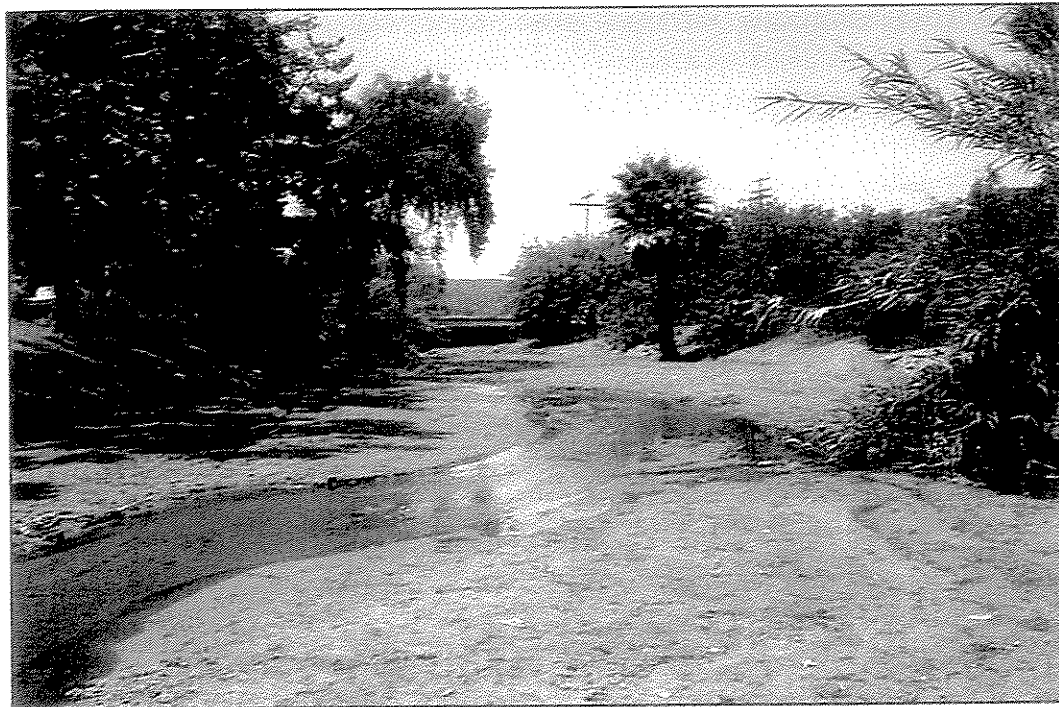
PHOTOGRAPH 2
Agua Hedionda Creek - View of El Camino Real Bridge
